HIGHWAY RESEARCH RECORD

Number	Design of
343	Traffic Safety Barriers
	10 Reports

HIGHWAY RESEARCH BOARD

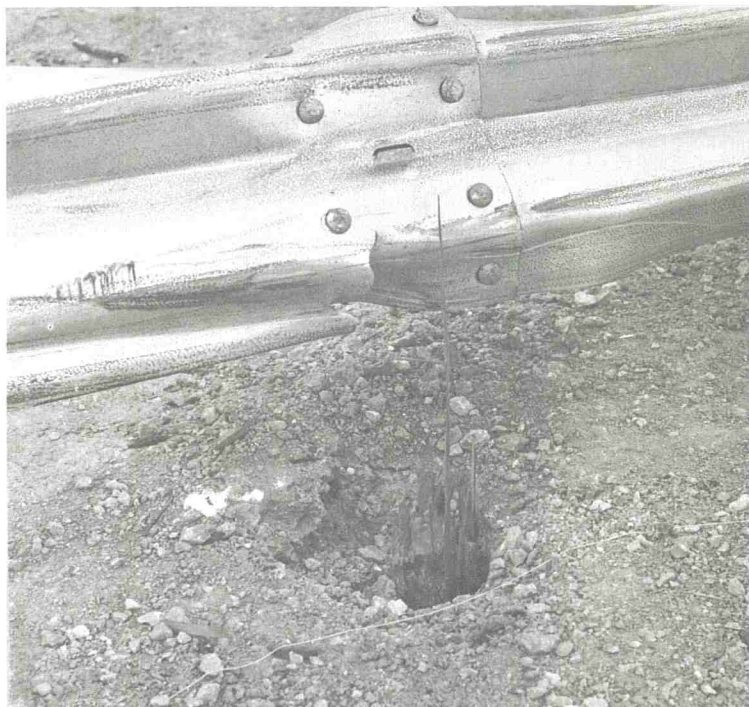
(c) Typical post failure (note tear in rail section)
